U.S. Department
of Transportation
**Federal Aviation
Administration**

Aviation Maintenance Alerts

**ALERT NO. 253
AUGUST 1999**

**Improve Reliability-
Interchange Service
Experience**

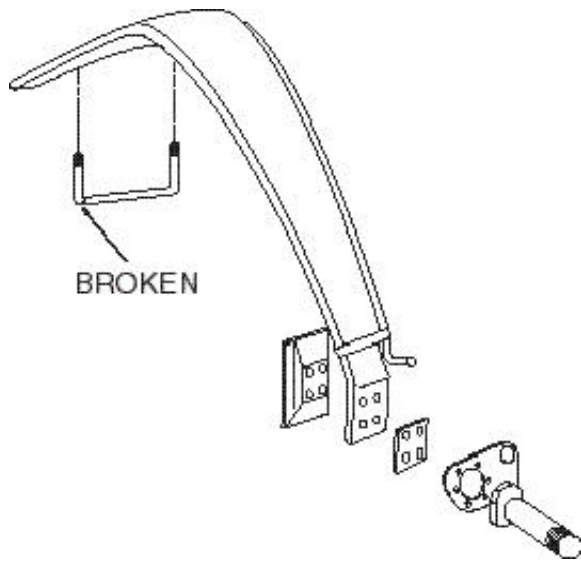
American Champion; Model 8KCAB; Decathlon; Landing Gear Failure; ATA 3211

An investigation disclosed that the right main gear "U-bolt" attachment had broken. The location of the broken "U-bolt" (P/N 1-9805) is at the point where the gear leg came out of the fuselage. This allowed the gear leg to pivot approximately 12 inches fore and aft. (Refer to the following illustration.)

The submitter suggested frequent inspections of the "U-bolt" attachment.

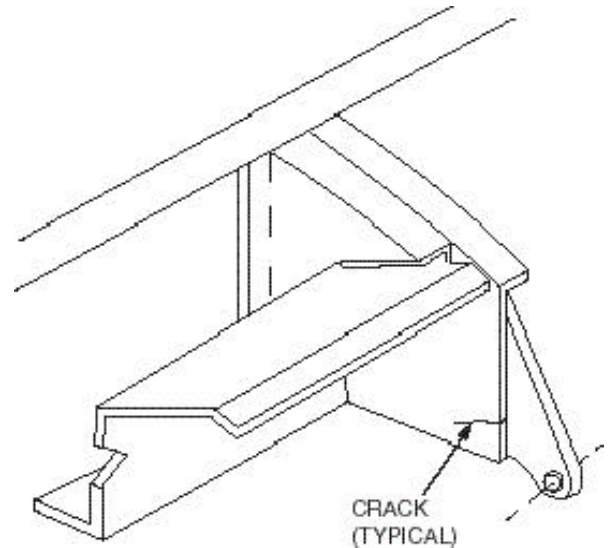
Beech; Model 76; Duchess; Wing Rib Cracks; ATA 5751

During a scheduled inspection, the technician found cracks in two wing ribs

The cracks appeared where the inboard and outboard aileron hinge plates (P/N 105-100011-51) were attached. (Refer to the following illustration.) The submitter stated, "The same problem has been found on

other aircraft of the same model. In all cases, the cracks were repaired by installing a doubler on each defective wing rib."

This area deserves your attention during inspections.

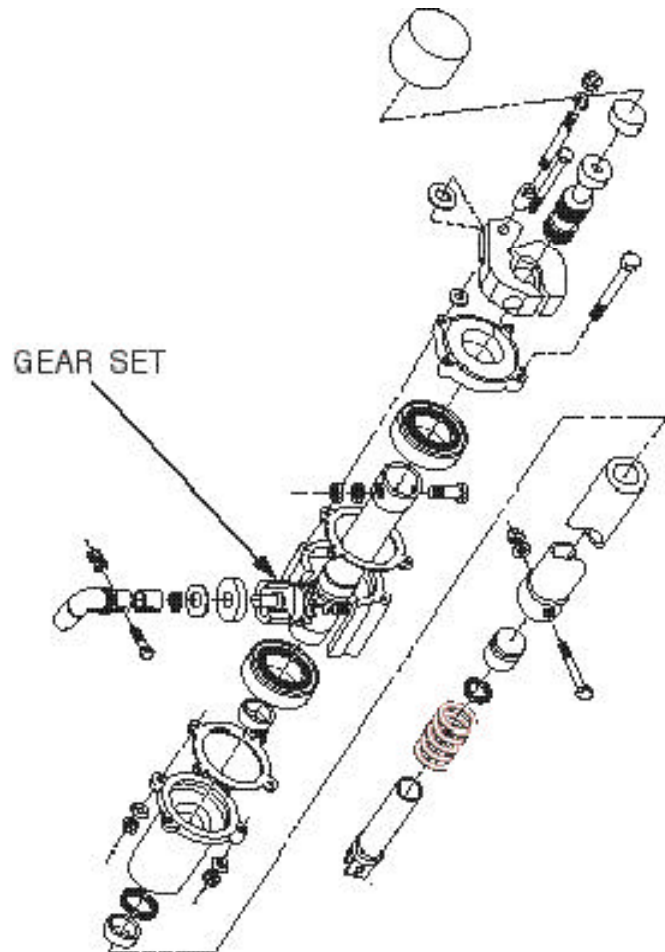
Beech; Model B-100; King Air; Landing Gear Failure; ATA 3230

During a landing approach, the right main landing gear would not extend. Both the normal and emergency extension systems failed, requiring a landing using only the left main and nose gear. The aircraft sustained substantial damage during the landing.

An inspection of the landing gear system revealed that the gear drive shaft sheared. This disabled the actuator (P/N 99-810057-651) and prevented the landing gear from being extended. The drive shaft failed at the right

gear actuator internal drive "gear set" (P/N 99-810127-1). (Refer to the following illustration.)

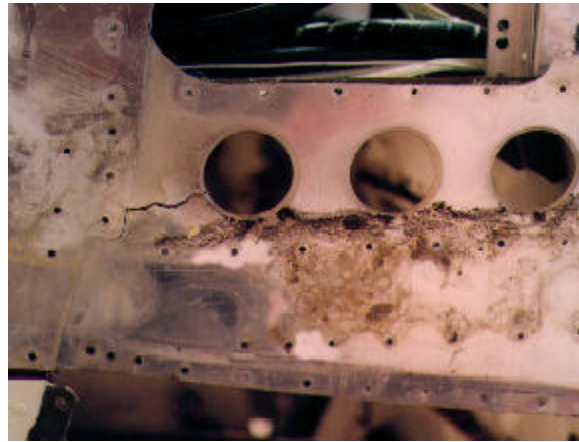
Cessna; Model 210M (C210); Centurion; Accumulator Snapping Failure; ATA 3231

When the technician inspected the aircraft, he discovered the left main gear door accumulator (P/N 1281033-1) failed at the snapping. The stringer in that area had become crushed and a hole was visible in the exterior skin and was replaced. (Refer to the following illustration.)

The submitter speculates the part simply failed or failed resulting from improper installation. The part had 315 cycles and 177 hours since the last overhaul. The maintenance manual does not contain specific inspection criteria for this part.

The submitter stated the part should be reinspected 25 to 50 hours after resealing maintenance, and it should be added to the main landing gear overhaul list.

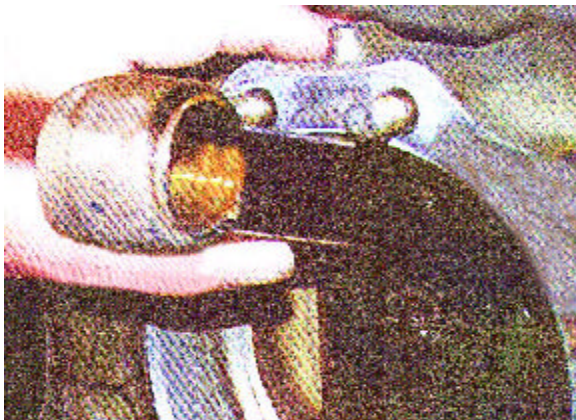
**Cessna; Model T210N (C210); Turbo Centurion; Connecting Rod Bushing; ATA 8530**

During an engine repair inspection, the technician discovered a rod bushing on the number 2 cylinder's connecting rod was pushed out of place approximately 1/8 inch. (Refer to the following illustration.)

Further inspection revealed two more bushings with the same problem. The engine was "top overhauled" 1,208 hours after a major overhaul. It operated an additional 361 hours with the improperly-installed bushings. The submitter determined the previous mechanic used a great amount of force when he installed the piston pins moving the bushing out of their proper position.

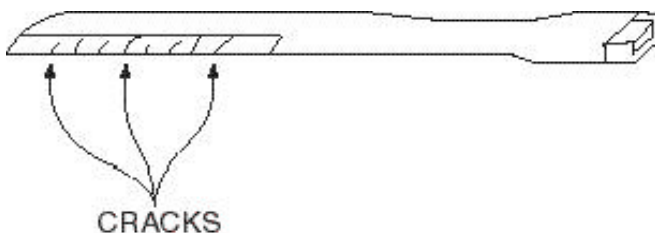
Eurocopter; Model EC135PL; Main Rotor Blade Structural Defects; ATA 6210

While conducting a main rotor blade inspection, the technician thoroughly cleaned the main rotor blade (P/N L621-M1010-054). He discovered eight hair-line cracks on the main rotor blade's leading edge erosion protective strip. (Refer to the following illustration.)

The technician could not see the cracks until he conducted the cleaning process. He recommends cleaning and inspecting the main rotor blades at frequent and regular intervals.

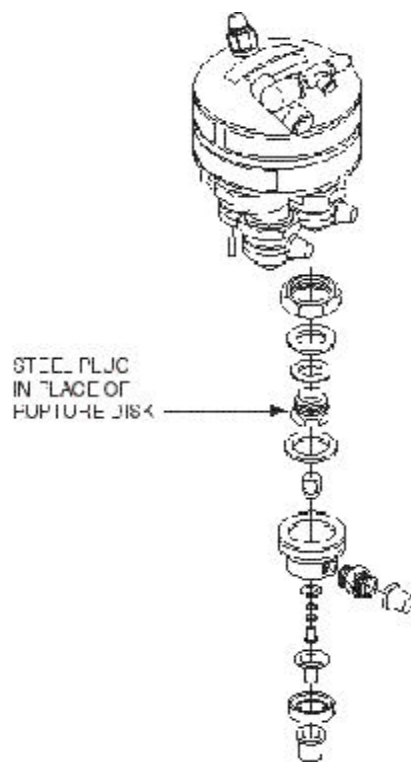
After a receiving inspection, the unit was routed to the production department for accomplishment of the necessary work. The unit was found to be full of extinguishing agent and was purged. While disassembling the fire extinguisher, the technician noticed that the "yellow" outlet rupture disk had been fired even though the cylinder was full when it was received. Further disassembly disclosed that a "steel plug," used for pressure testing, had not been replaced with the rupture disk prior to final assembly. (Refer to the following illustration.) After contacting the owner and discussing the discrepancies, it was speculated that the "steel plug" had been overlooked during a previous overhaul at another shop.

Many times, emergency equipment is neglected or not given proper care. It sits in its installed position for long periods of time and is not noticed until it is needed. When needed, this equipment **MUST** work. In fact, your life may depend on the proper operation of this equipment.

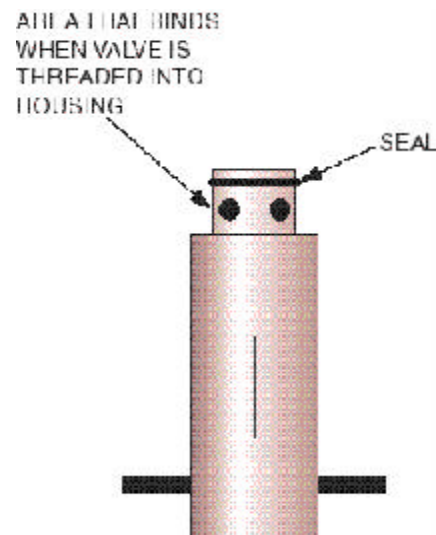
FUEL DRAIN VALVES

After the submitter installed a new fuel drain valve (Curtis P/N CCA1550) in an aircraft, it would not open.

It appeared the shaft was binding on the housing in the area just below the seal. (Refer to the following illustration.) The submitter used a 10-power magnifying glass to view the affected area. The drain valve package indicated the manufacturer produced the drain valve in the fourth quarter of 1998. The submitter did not offer any other details concerning this problem.
